Niagara Falls Radiation Sites

Niagara Falls Boulevard, Holy Trinity Cemetery

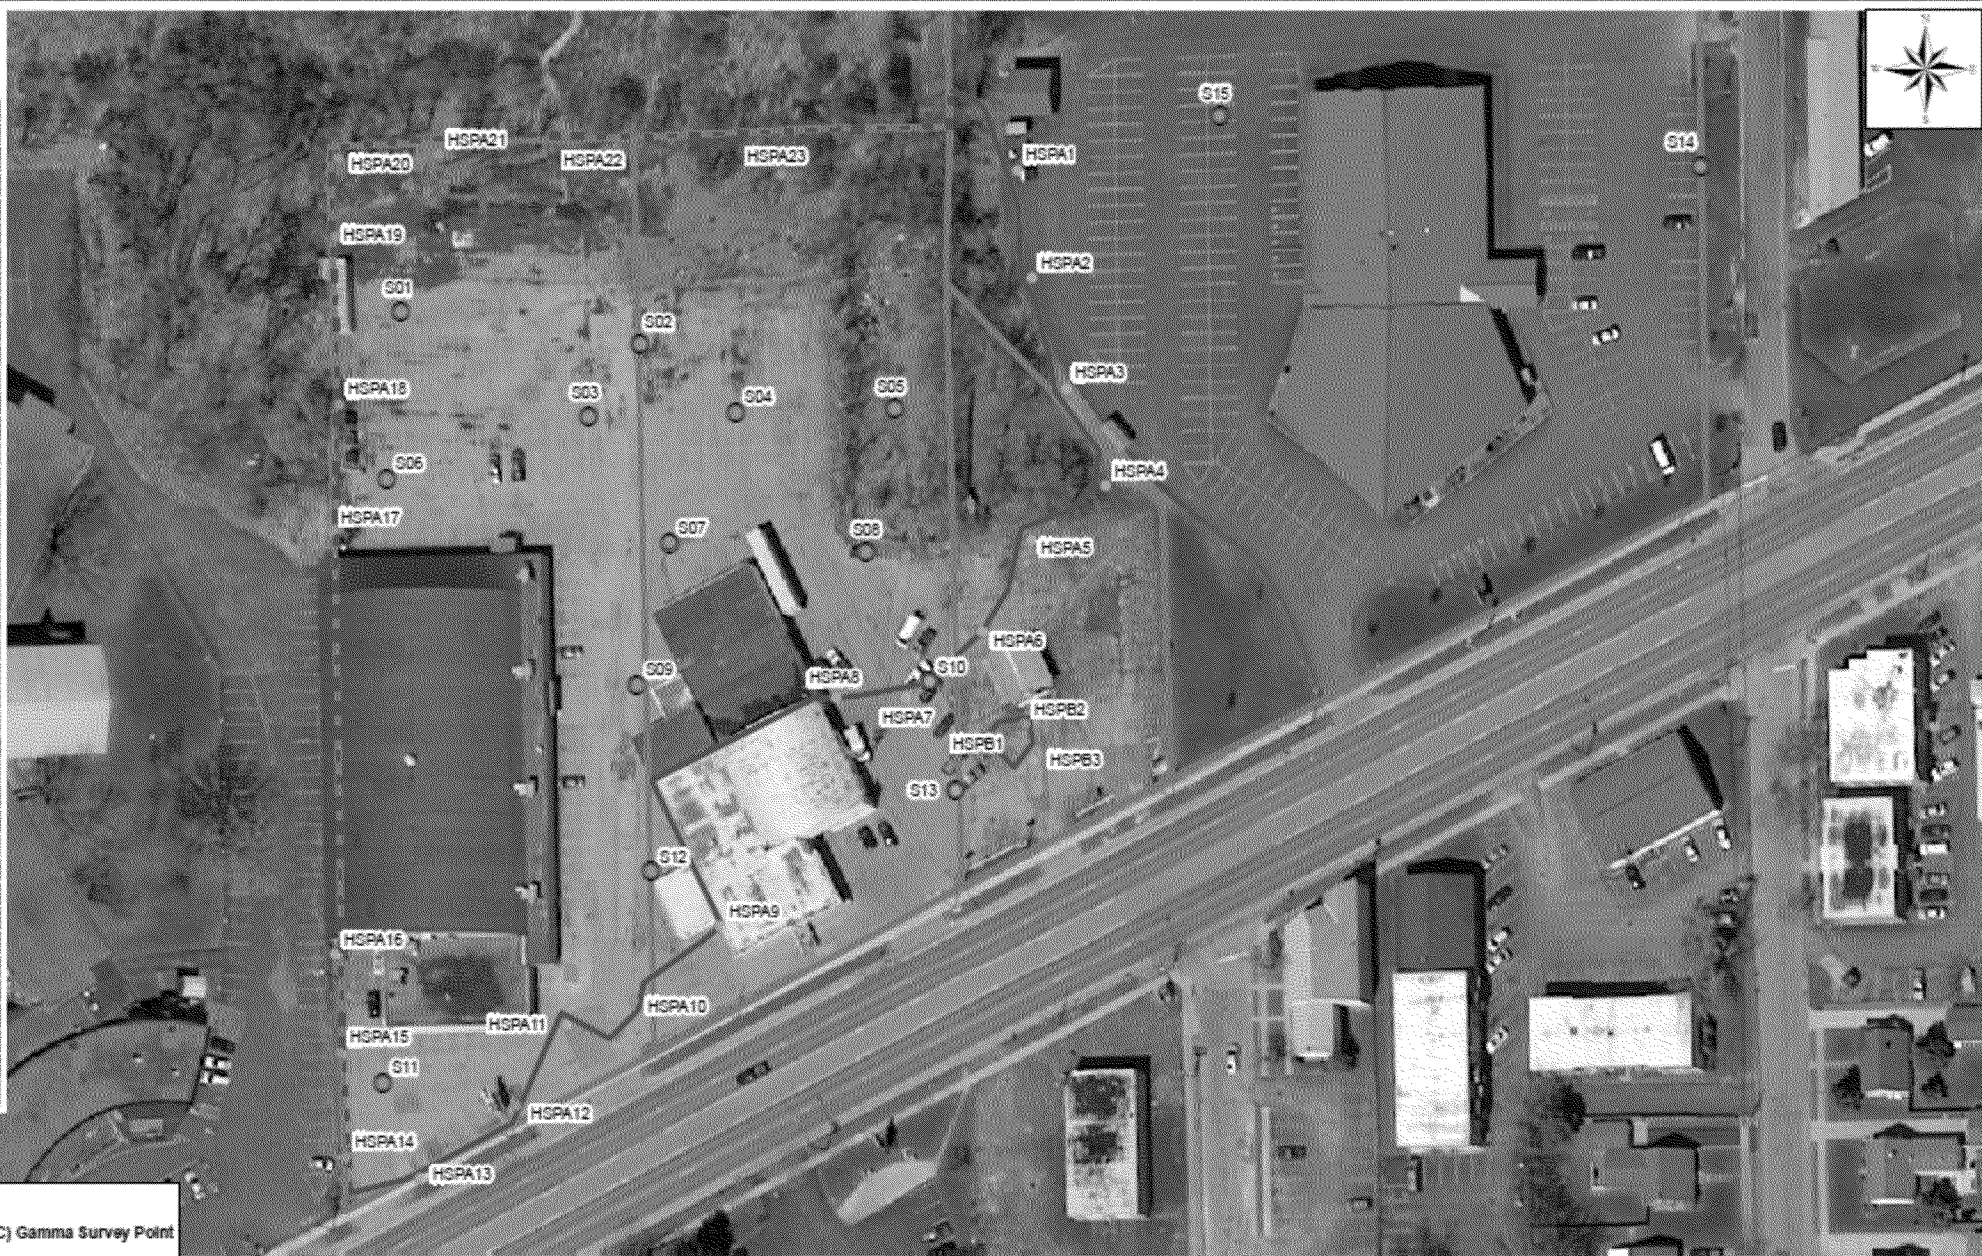
Location ID	Gamma Radiation Exposure Rate (μR/hr)
G14	8.452
G15	7.773
G01	96.928
G02	151.864
G03	33.696
G04	121.794
G05	330.81
G06	97.744
G07	178.744
G08	118.032
G09	91.768
G10	11.644
G11	39.82
G12	123.654
G13	9.298
HSPA1	10.68
HSPA2	11.218
HSPA3	10.23
HSPA4	13.04
HSPA5	10.594
HSPA6	10.652
HSPA7	9.996
HSPA8	16.026
HSPA9	14.282
HSPA10	20.81
HSPA11	11.336
HSPA12	17.724
HSPA13	12.07
HSPA14	42.956
HSPA15	21.316
HSPA16	12.56
HSPA17	57.388
HSPA18	97.074
HSPA19	96.946
HSPA20	68.674
HSPA21	37.602
HSPA22	50.596
HSPA23	36.738
HSPB1	26.316
HSPB2	18.25
HSPB3	10.402

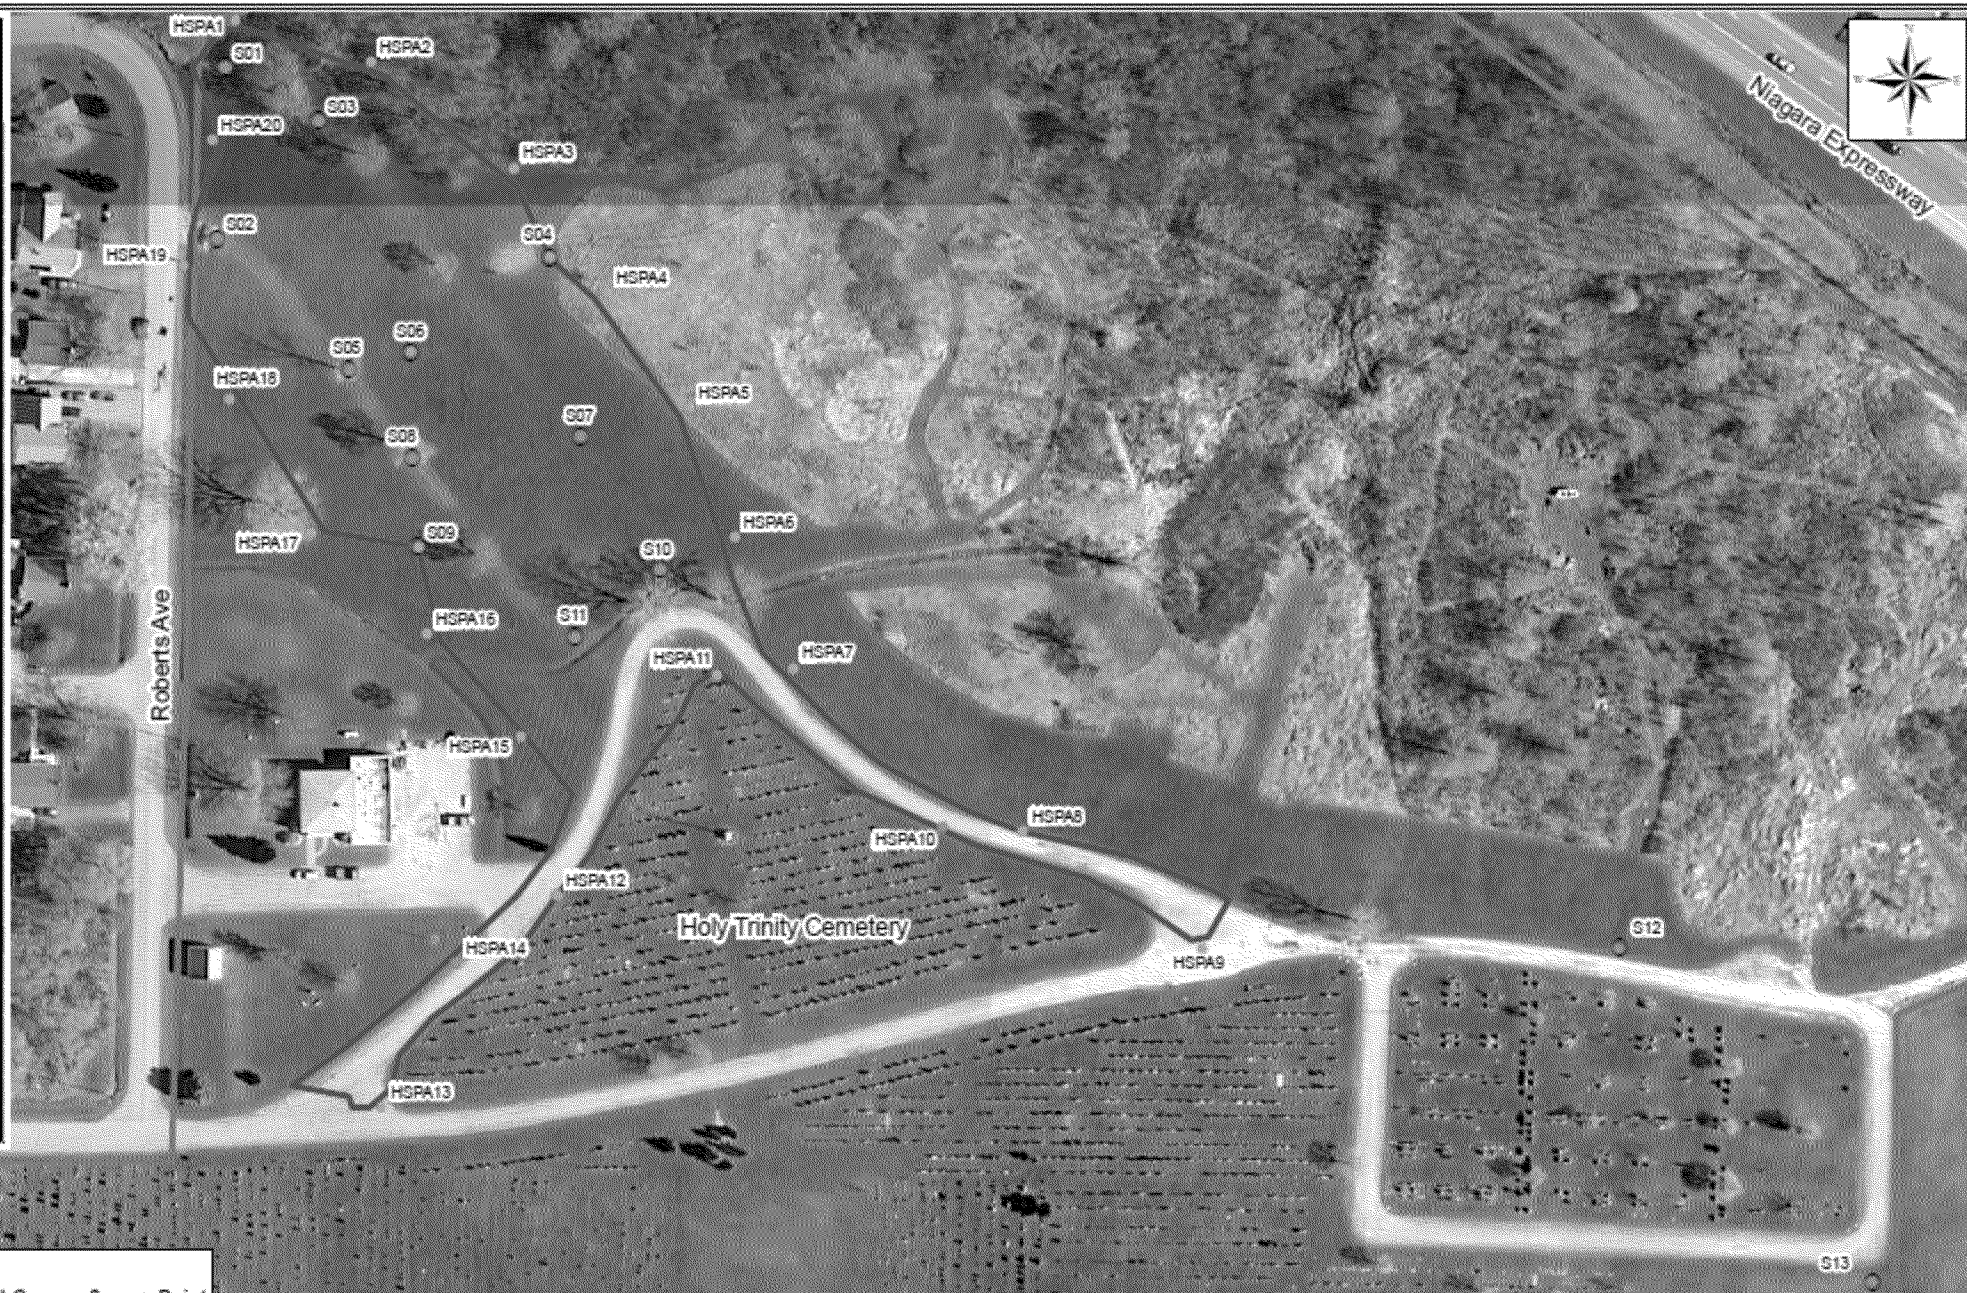
Location ID	Gamma Radiation Exposure Rate ($\mu\text{R/hr}$)
S12	9.385
S13	9.163
S01	134.01
S02	109.00
S03	239.436
S04	15.784
S05	342.544
S06	18.222
S07	238.968
S08	378.44
S09	17.128
S10	194.054
S11	281.822
HSPA1	13.014
HSPA2	11.532
HSPA3	11.018
HSPA4	11.566
HSPA5	11.424
HSPA6	11.482
HSPA7	10.328
HSPA8	16.362
HSPA9	11.058
HSPA10	19.872
HSPA11	12.610
HSPA12	15.898
HSPA13	16.424
HSPA14	19.548
HSPA15	11.552
HSPA16	12.35
HSPA17	11.61
HSPA18	11.71
HSPA19	11.496
HSPA20	12.068
